Shearing Strength of Concrete

THESIS

DEGREE OF BACHELOR OF SCIENCE

UNIVERSITY OF ILLINOIS

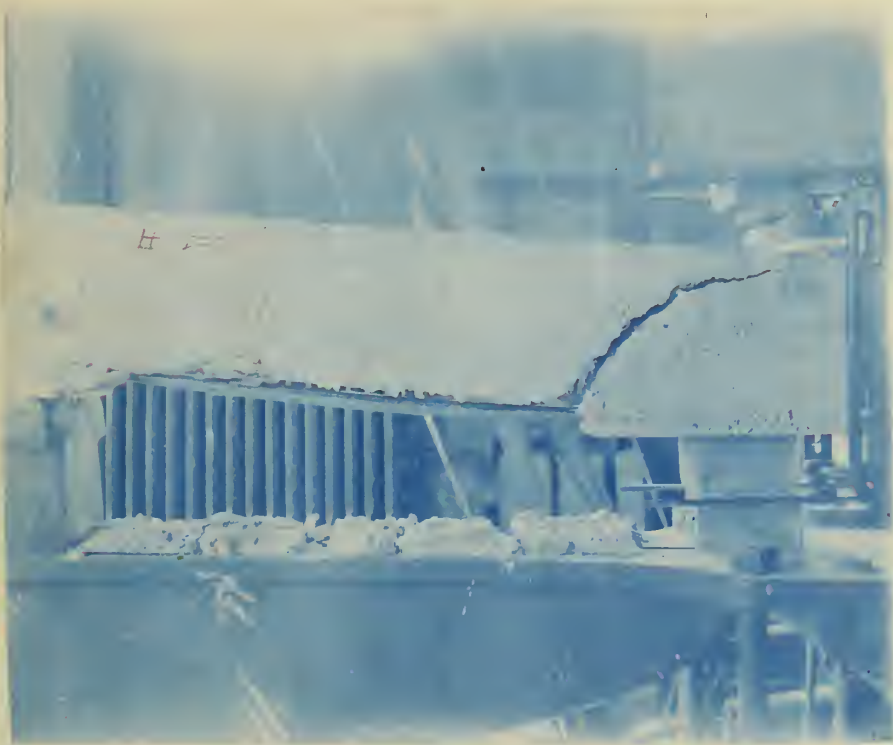
The photograph on Plate IX shows

very clearly the nature of the break

as the beam appeared in the machine.[#]

*Plate IX**BULEPRINT SHOWING DIAGONAL CRACK*

The blue print on Plate LX. page 21, shows the manner of failure of these beams. From an inspection of the beam after the concrete had dropped from the bottom, it would be seen that the rods had slipped, and hence horizontal shear was not the cause of this particular failure.
